TEST REPORT

Sample / Report No. ELD3170082021

Sample Type Pressure Transducer

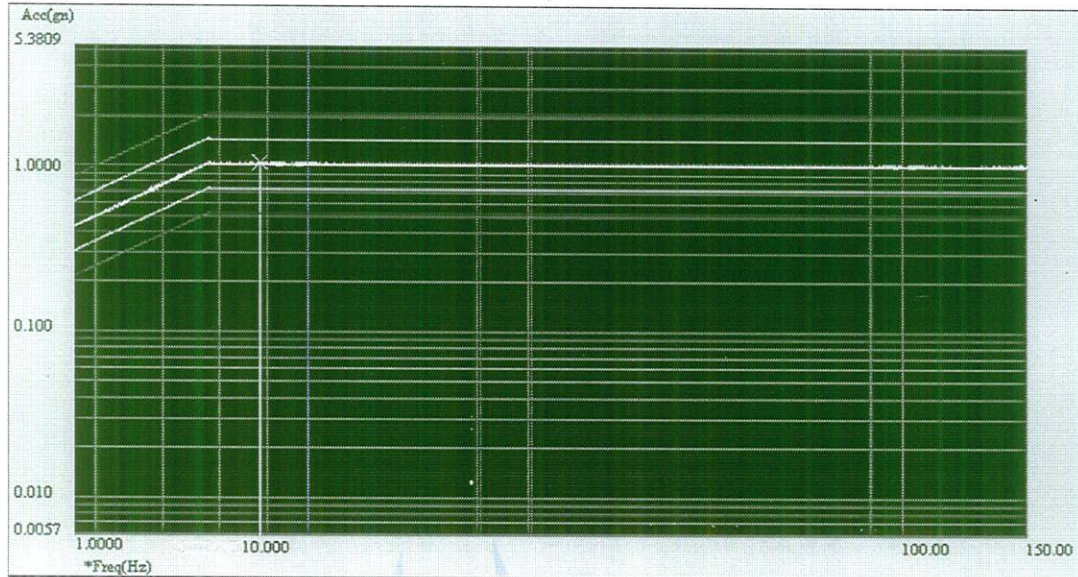
Sine vibration test profile

Sr. No.	Clause No.	Parameter & Test Conditions	Test Requirement	Measured/ Values/ Observations	Remark										
1.	Sine Vibration test (IEC 60068-2-6)	Freq. Range 10-150Hz, 10m/s ² (1g _n), 3 axes, sweep rate 1 octave/min 1 sweep/axis	Visual examination	No visual damage observed	Satisfactory										
2.	Random Vibration Test (IEC 60068-2-64)	Duration: 5 Hours in each Orientation. Duration : 15Hours

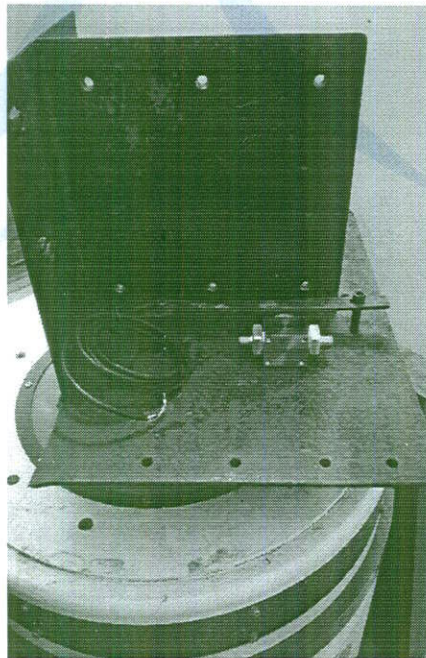
Test set up X-Axis

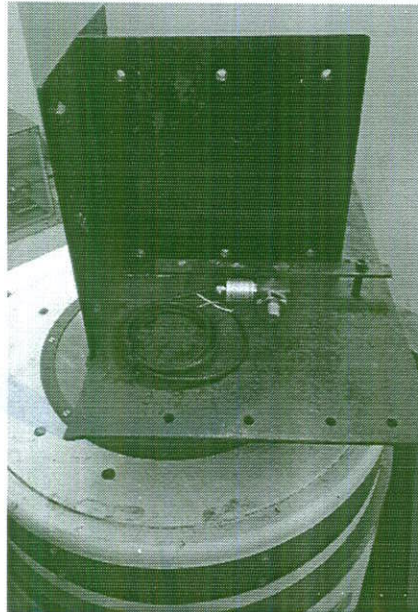
Test set up Y-Axis

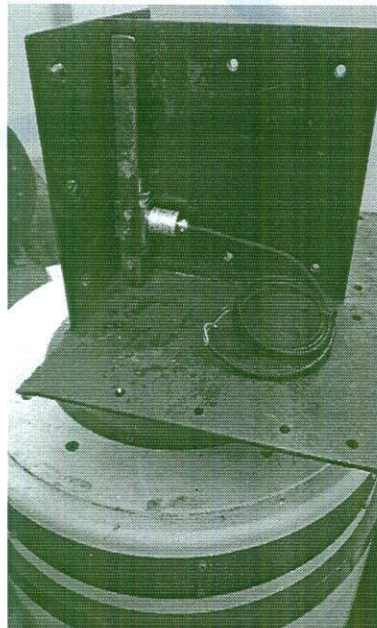
Test set up Z-Axis

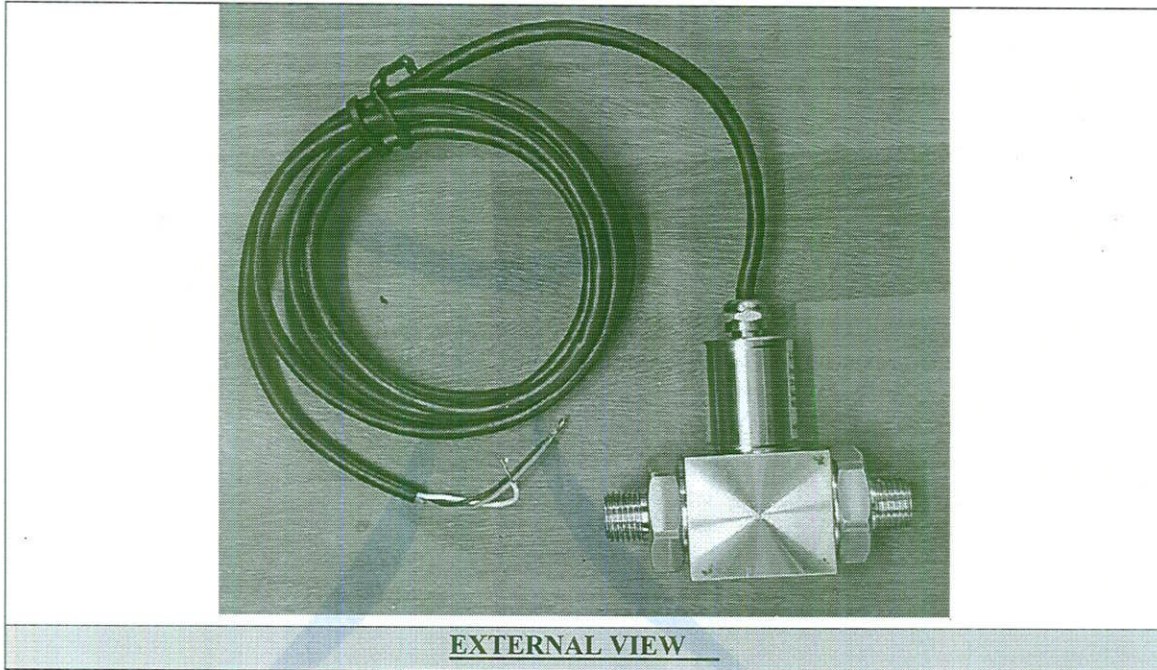
PHOTOGRAPH OF SAMPLE

EXTERNAL VIEW
